P A R T    I I I

SANITARY SEWER SYSTEM - BASIS OF DESIGN

SANITARY SEWER SYSTEM  
ANALYSIS, EVALUATION AND RECOMMENDED  
CONSTRUCTION

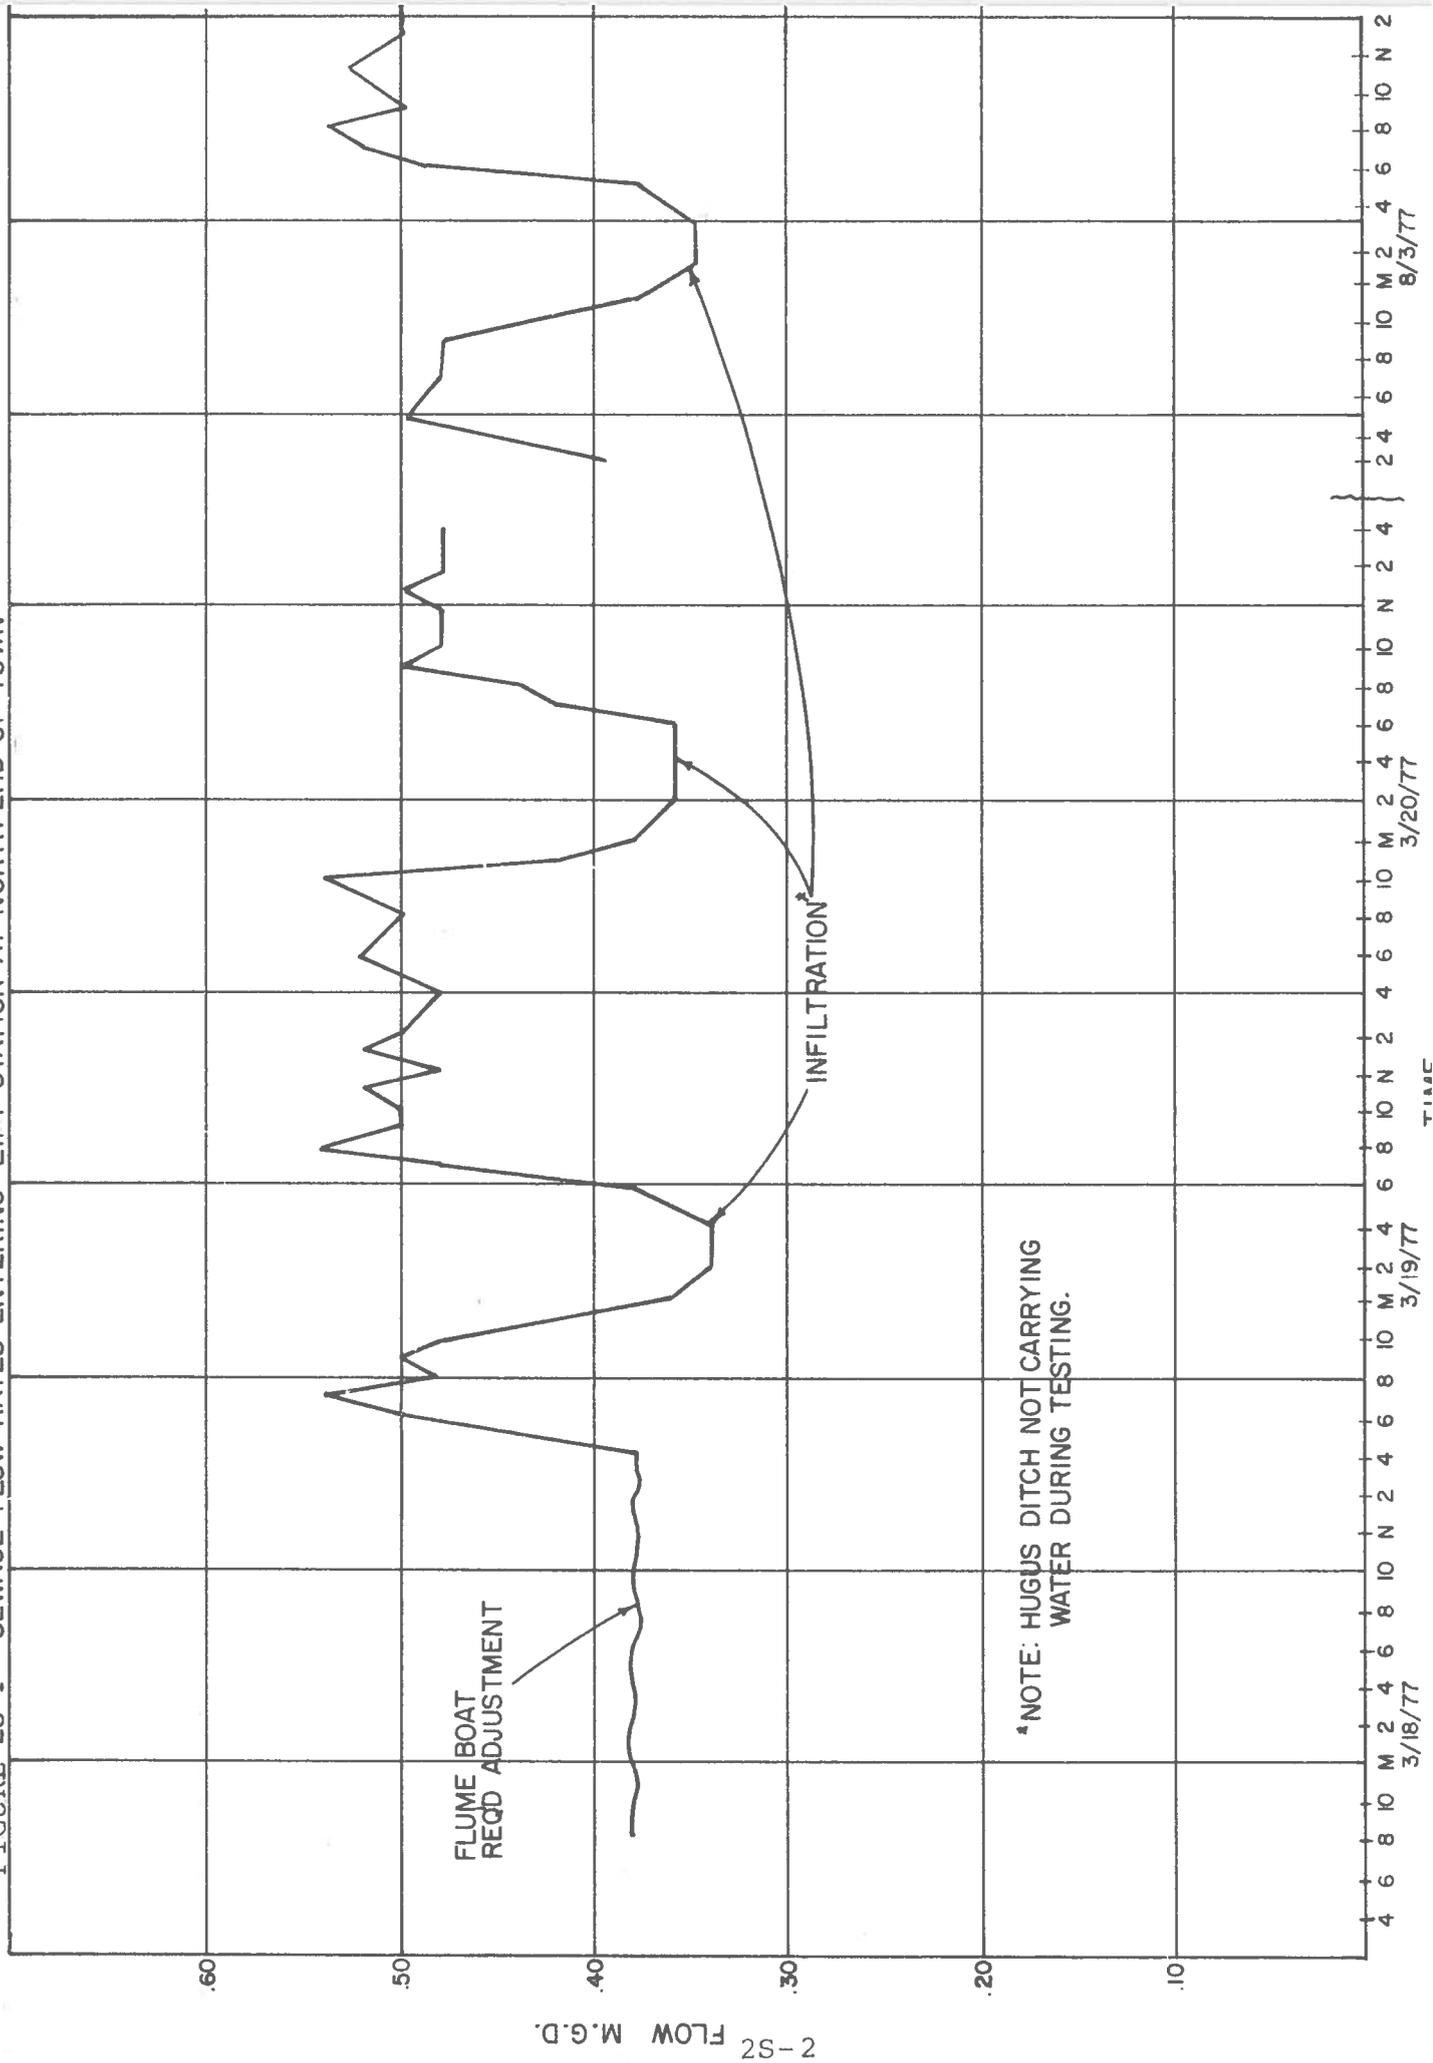
FIGURE 2S-I SEWAGE FLOW RATES ENTERING LIFT STATION AT NORTH END OF TOWN

NOTE: HUGUS DITCH NOT CARRYING WATER DURING TESTING.

The 10 inch diameter collector line was monitored for 36 hours on two occasions. The flow during the peak hours were compared to flows during the middle of the night to determine the volume of infiltration. Our results shown in Figure 2S-1 indicate as much as 0.6 C.F.S. infiltration occurs in the 10 inch line. This is more than one half of the total flow that the line is capable of carrying. The total carrying capacity of the 10 inch line on Third Street is

0.73 C.F.S. This amount of infiltration is equal to a population of 2100 people and cuts the carrying capacity of actual sewage to about 1000 people. Thus the line becomes overloaded and begins to back up. In addition, that section of 10 inch sewer on Third Street between Rochester and Hugus Street is a bottle neck for the remainder of the line. The capacity in this location is .73 C.F.S. or 3100 people, but the velocity of flow is only 1.34 f.p.s., inadequate for self scouring.

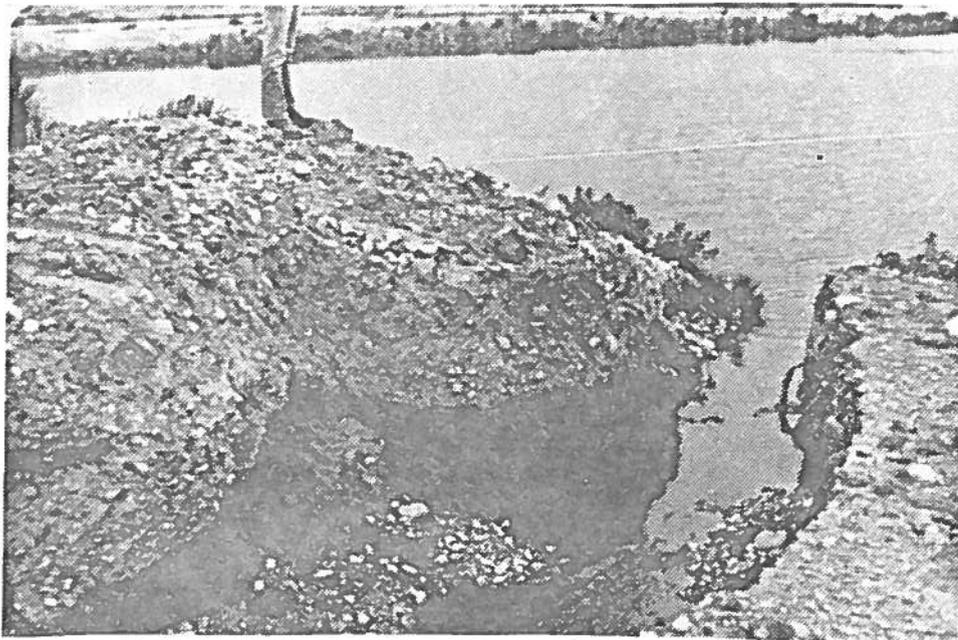
Fig. 5S-2

In addition to the back up problems experienced on the west side of Town, the east side of Town also had problems. The outfall line backed up all the way from the lagoons, and caused flooding of

trailer homes and other residences on the eastern side. The cause of this was that the volume of sewage and infiltration water being pumped from the lift station on the west side of Town was considerably more than the 10 inch outfall line and 10 inch diameter lagoon piping could carry. The capacity of the 10 inch diameter outfall line is 0.9 C.F.S. In the summer of 1977, W.E.A.I. recommended that to immediately alleviate this problem of temporary drainage channel at the lagoon should be dug to help drain the lagoons more quickly. W.E.A.I. also recommended that the Town immediately apply for funding to increase the size of the outfall line and lagoon piping. The recommended construction was designed to carry the flows of a population of 10,000 people or 3.7 C.F.S. in addition to the 0.85 C.F.S. capacity of the existing 10 inch diameter outfall line. A 15 inch diameter outfall line was recommended. In addition the lagoon piping connecting the two present lagoons, and the effluent piping discharging from the lagoons were increased to provide a flow through capacity for a population of 10,000. This construction was funded by a State Mineral Royalties Grant obtained in the Spring of 1978, and construction was started in May, 1978.

Temporary By-pass at  
Second Cell, Dug to  
Relieve Backup Prob-  
lems in Town-1977

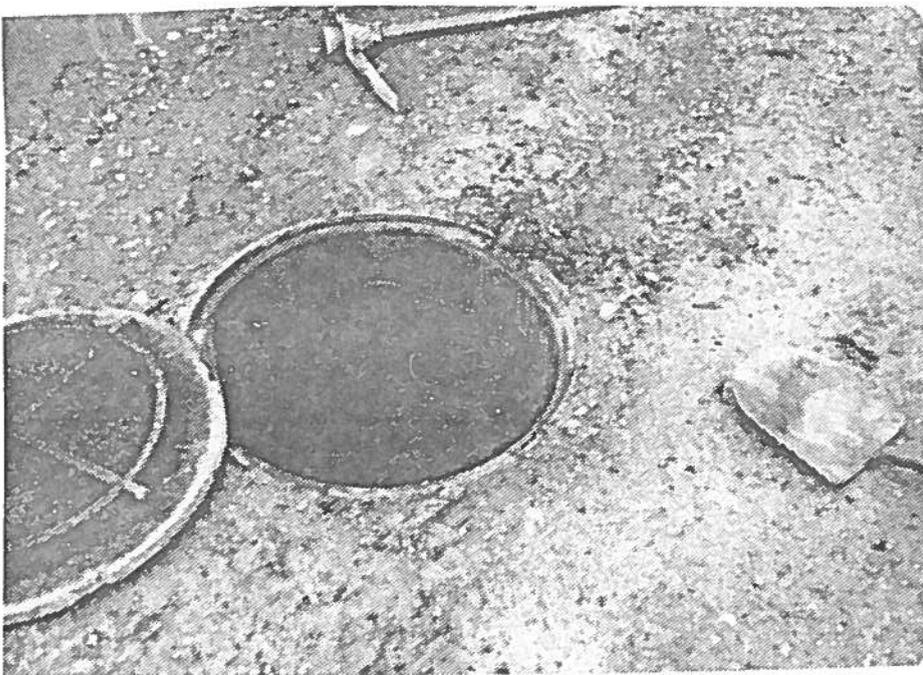
Fig. 5S-5

Manhole on Chatterton and  
E. Veterans St. Full Due  
to Undersized Lagoon  
Piping

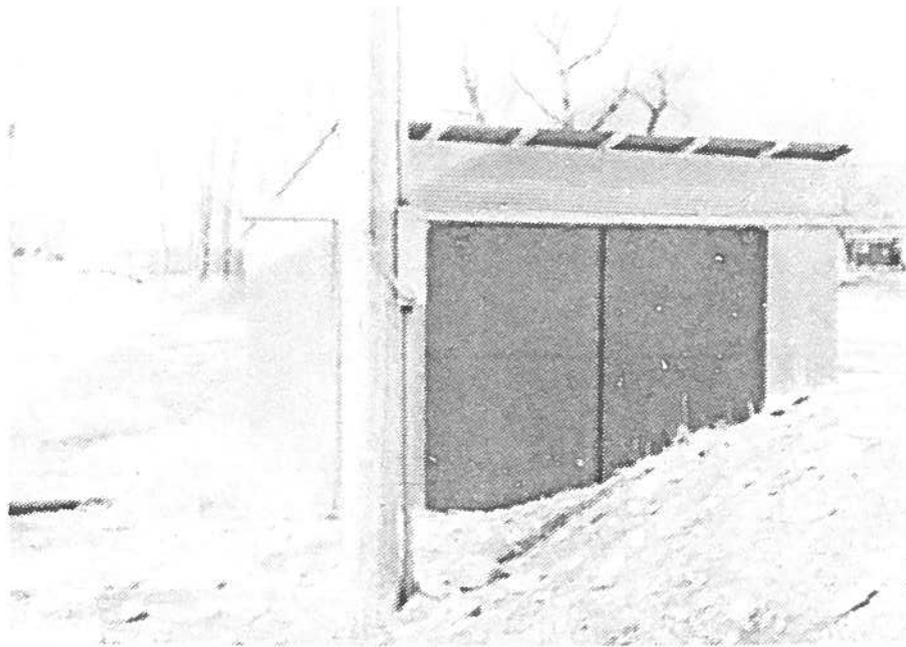
Fig. 5S-7

The existing lift station prior to being renovated in 1978 was installed in 1972. It was a packaged lift station which consisted of two air vacuum primed sewage lift pumps that pumped waste from a concrete wet well. These pumps were very difficult to prime, and clogged easily. The controls on the system were far more complicated than necessary, and thus required continual maintenance and repair. The lift station simply was inadequate.

The existing Lift Station Building  
Prior to Renovation-1977

In late fall 1977, W.E.A.I. redesigned the lift station for renovation into a more reliable system. The two air vacuum primed pumps were replaced with two submersible non-clogging sewage pumps. These pumps require no priming, and have a recessed impeller that does not come into contact with the sewage. Each pump was designed to pump the maximum capacity of the line serving the lift station, 500 g.p.m. Therefore, one pump is to be used all the time, the other as a backup, and both can be used if future expansion occurs. Simple float controls were designed and installed that turn the pump on or off with the rising liquid levels in the wet well. With a fully reliable lift station, the back up problems due to the previous lift station failures on the west side of Town were solved.

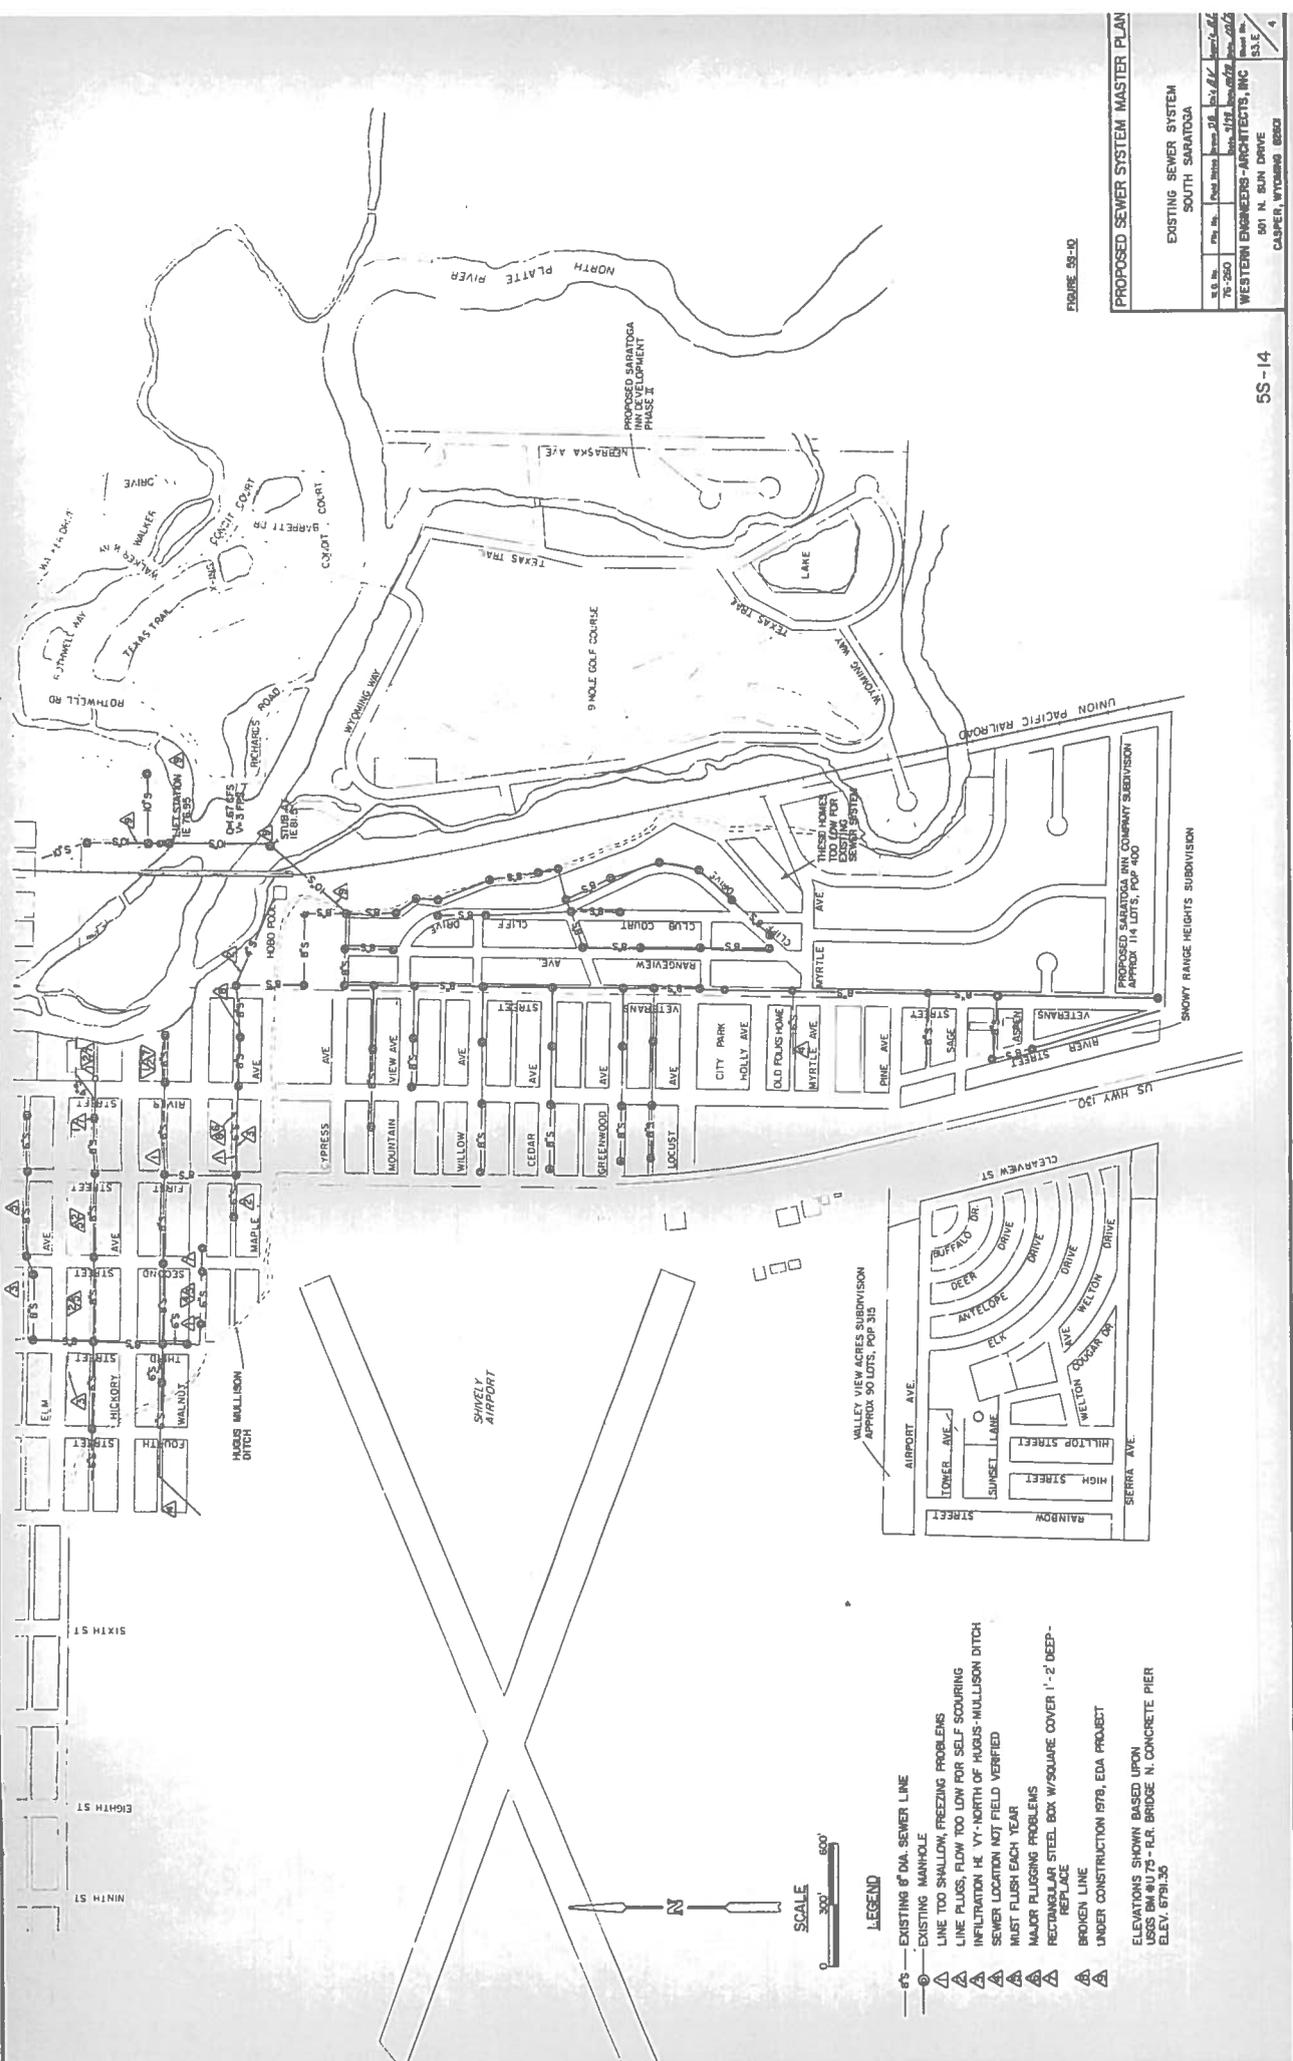
FIGURE 55-10

- c. Some sewer tile is broken due to the type of rocky soil surrounding the tile, the quality of construction, or depth of cover, or failure of the pipe material.
- d. The sewers that are leaking are doing so due to failure of materials, freezing causing cracking, etc. or the way the pipe was bedded or backfilled.
- e. Much 6" line exists that should be 8".

It should be pointed out that most of the sewer pipe material in this part of Town is vitrified clay pipe. Unless this type of pipe is properly bedded and covered with fine material, and back-filled properly during construction, it is subject to breakage. Improper construction control probably caused the majority of broken or clogged sewer pipe. In addition, this pipe was installed with open joints which is conducive to tree root growth and cracking at the joints of the pipe. This open joint pipe is the reason for the major infiltration problem.

6. Seal or repair the many small collector lines throughout Town that have infiltration, clogging or rodding problems as referenced on Fig. 5S-8 & 10. W.E.A.I. recommends that where the existing sewers are too shallow and/or flat to prevent winter freezing, that the sewers be replaced with double insulated water line pipe similar to Temp Tite water pipe produced by Johns Manville. In addition, shallow sewer pipe can be backfilled with a layer of saw dust or wood chips to prevent frost from reaching the pipe. The extra cost of this special pipe material and special backfilling required should be overcome in a few years by the savings from the Town crews not having to maintain and keep the lines from freezing and clogging during the winter.
