CHAPTER 10W. - SUPPLY TREATMENT AND
COLOR REMOVAL

The scope of this chapter is to describe, evaluate the existing treatment system, and make recommendations for improving the system. This chapter deals with the processes involved, the mechanical equipment, controls, and maintenance of the existing and proposed treatment facilities.

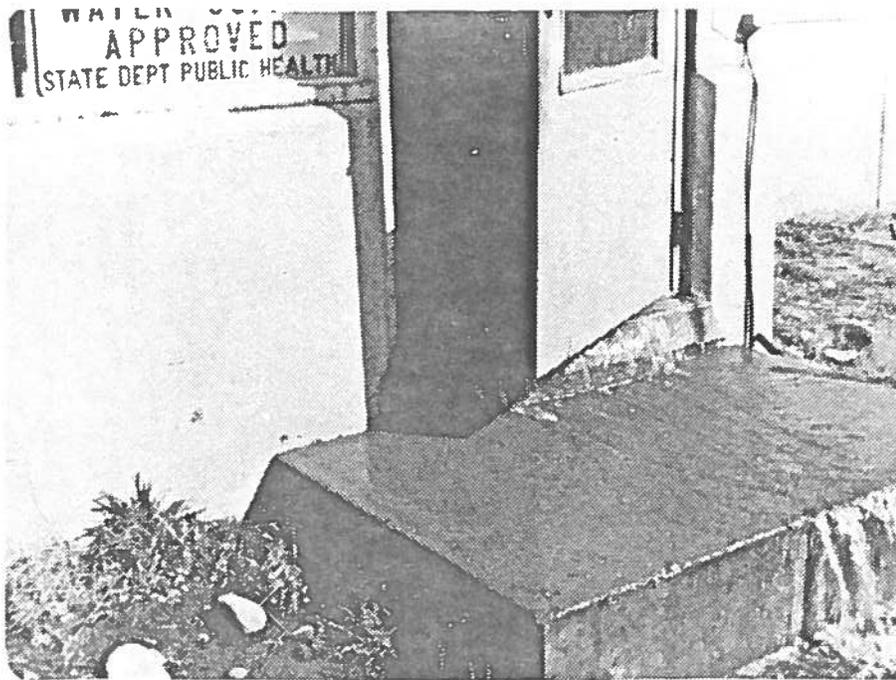
Fig. 10W-1

Discharge Ditch From Existing Water Treatment Plant to River

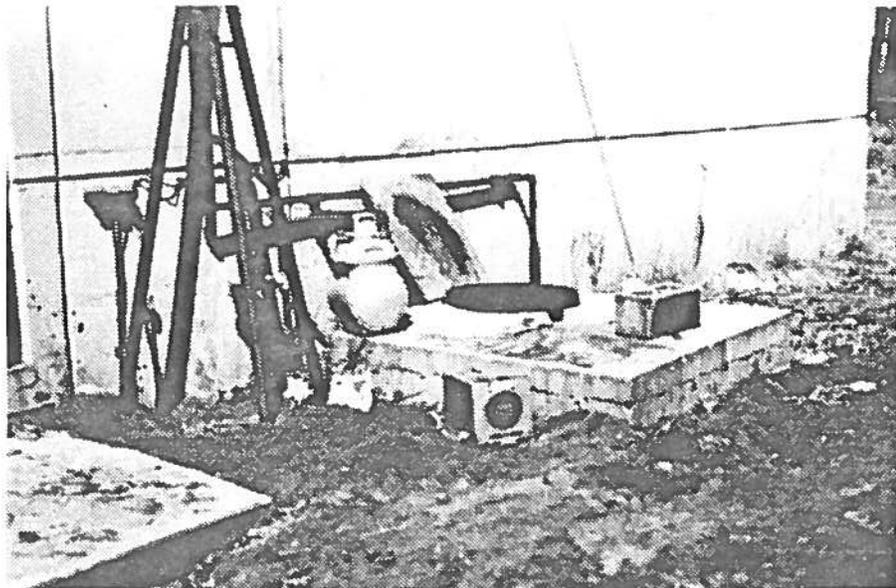
Fig. 10W-2

The 4 inch drain on the clarifier plugs easily, and thus the clarifier is not routinely drained. However, since the process is not efficient, sediment only rarely builds up to require frequent flushing.

Clarifier Manhole Drain Pit with Lid off, Subject to Freezing

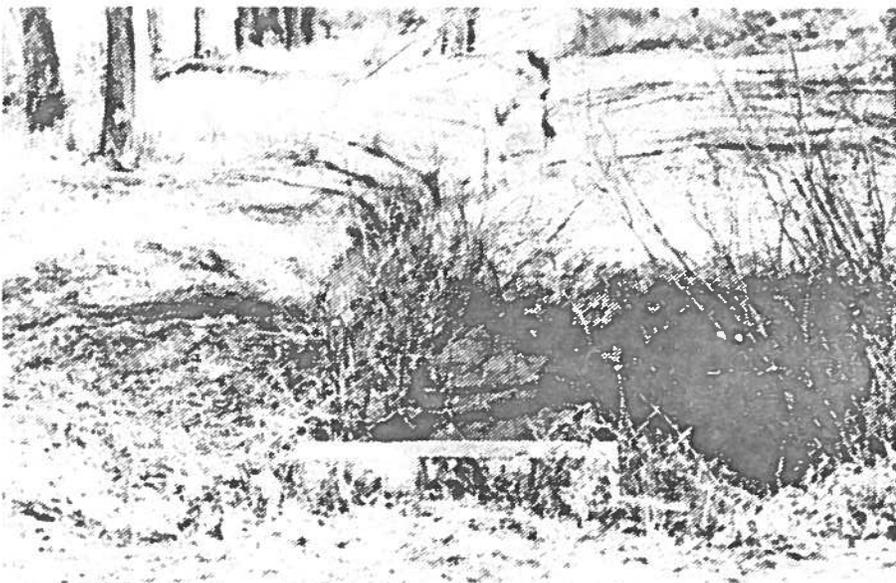
Fig. 10W-3

The electrical controls for the raw water pumps are not reliable. When the clear well has water in it, they pump. When the raw well is empty they shut off. The cause of the problem in Fig. 10W.-3 is the result of the raw pumps pumping even though the clear well is full, and hence the clear well overflows out the doors until the pumps are manually turned off or the raw well empties, and they automatically shut off. This flooding not only creates an inconvenience for the operator, it also creates a serious health hazard by contamination of the water in the clear well.

Filtered Water Flowing Out of Clearwell in Existing Plant, a Frequent Occurrence

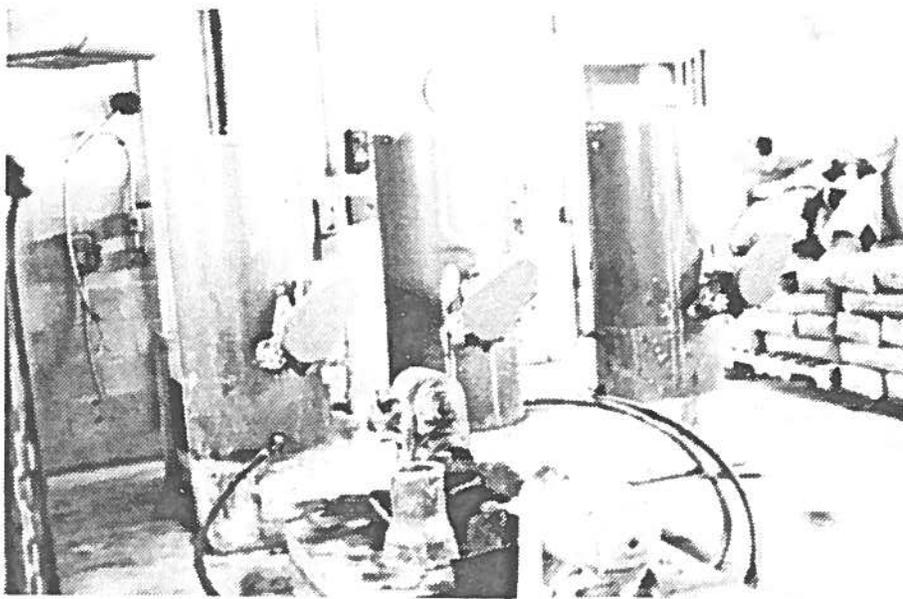
Fig. 10W-4

The three chemical feeders are not capable of running automatically or adequately proportioning the chemicals as required. They all leak, are not operable most of the time, and in general are inadequate for the majority of the time. They have not been maintained or taken care of.

Dry Chemical Feeders,
Existing Water Treat-
ment Plant

1. Renovation of raw water pumping system and metering it.
2. Renovation of the chlorination system.
3. Renovation of the clarifier and replacement of the three dry chemical feeders.
4. Renovation of the sand filters and underdrain system with mixed media.
5. Patching and some cleanup of the existing 80,000 gallon clear well structure.
6. Construction of a new fluoridation system to aid in the prevention of dental caries.
7. Replace the 3 high service pumps and piping, and renovating the existing metering system to be a totalizing indicating and recording system (T.I.R.).
8. Renovate or replace the telemetering system and automatic controls system.
9. Renovate or replace the existing internal plant electrical system and controls system.
10. General patchwork and renovation of the interior and exterior of the water plant structure.

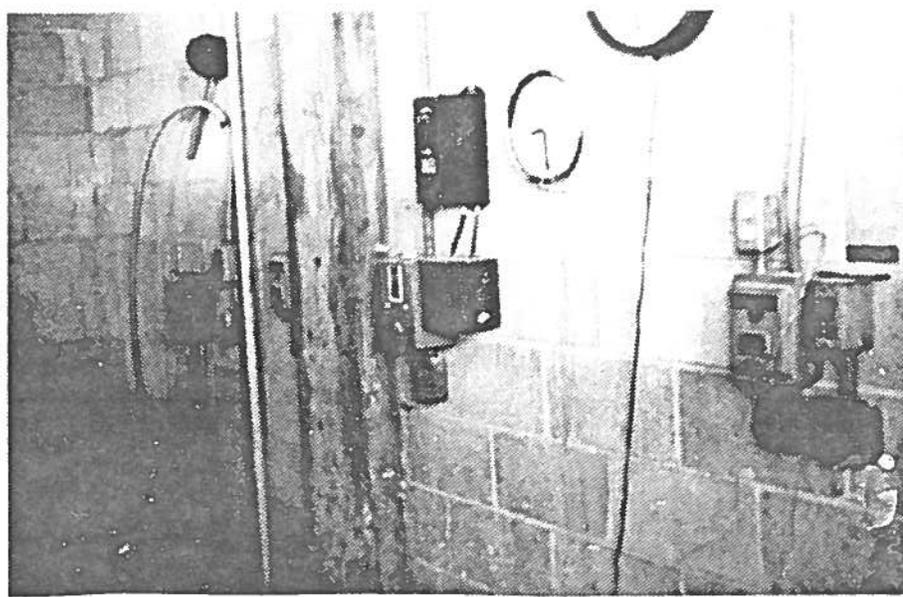
Fig. 10W-5

Manual Controls for Each
Chemical Feeder in Exist-
ing Water Treatment Plant

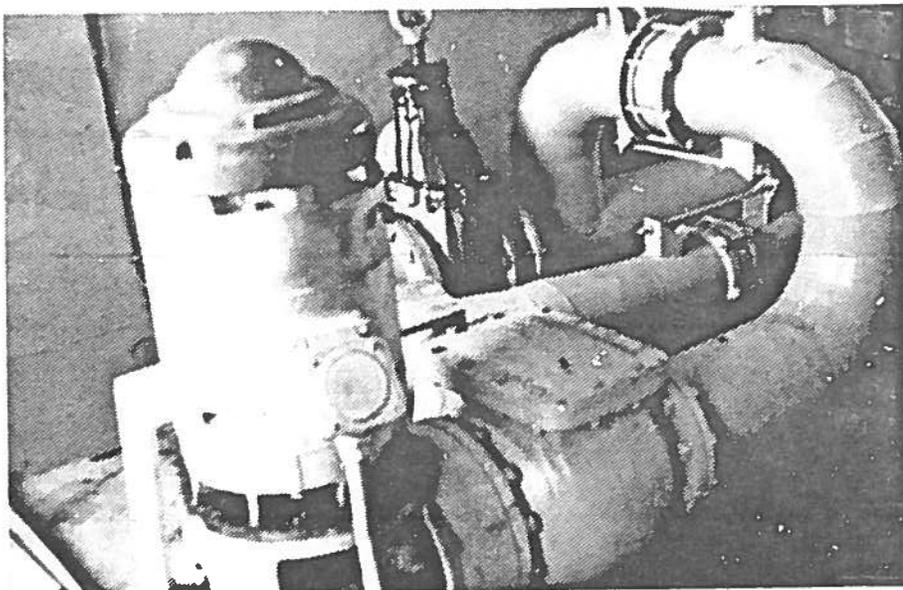
Fig. 10W-6

Backwash Pump, Existing
Water Treatment Plant

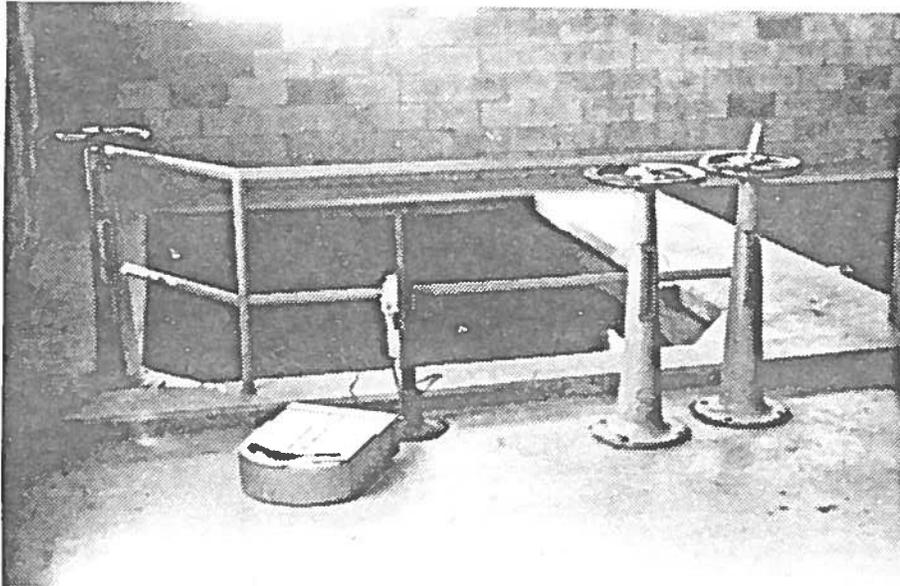
Fig. 10W-7

Valve Pedestals and Pressure Indicating Device on East Filter in Existing Water Treatment Plant, Not Operable-1977

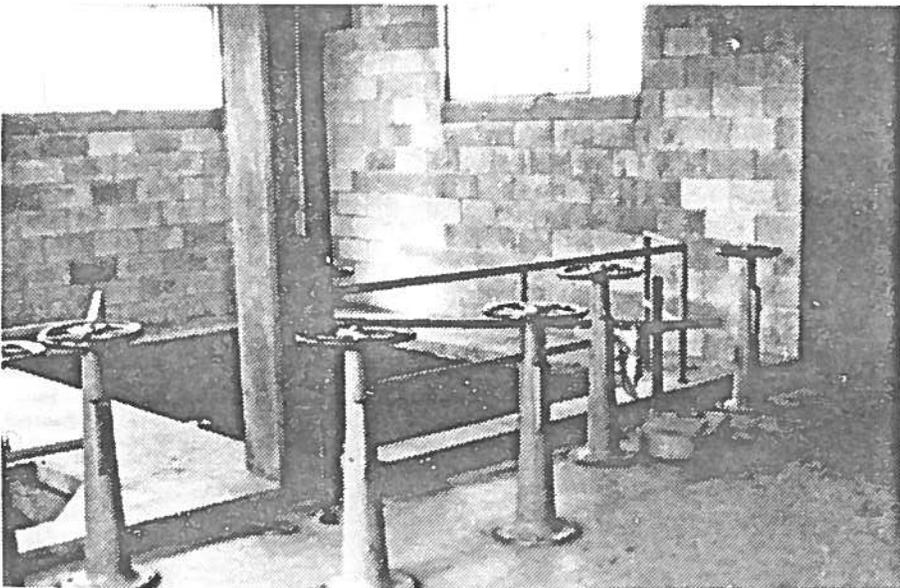
Fig. 10W-8

In addition, the valving on the filter piping system is leaky and not easily operable. Fig. 10W.-8 shows valve stems that are not operable. The plug valves on the backwash drain lines leak continuously, and during the winter months cause large ice buildups and a hazard behind the plant as shown in Fig. 10W.-9.

Valve Pedestals and Pressure Indicating Device on West Filter, Not Operable in Existing Water Treatment Plant

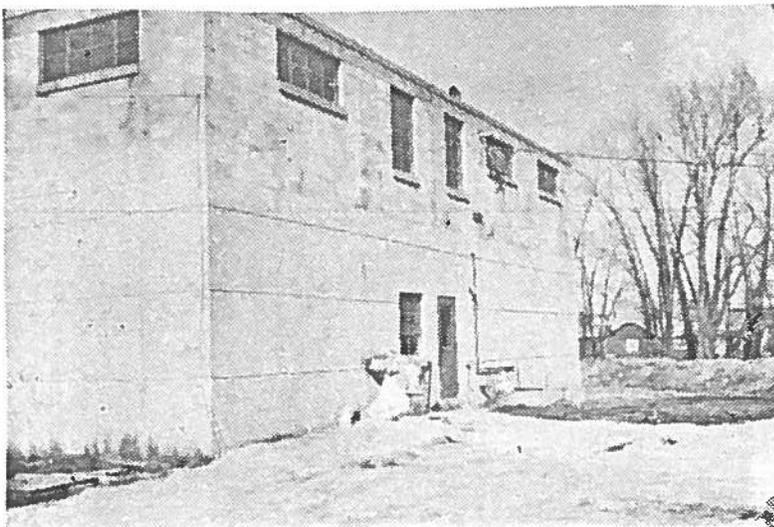
Fig. 10W-9

Ice Build-up Behind Existing Water Treatment Plant Due to Leaky Sand Filter Drain Valves

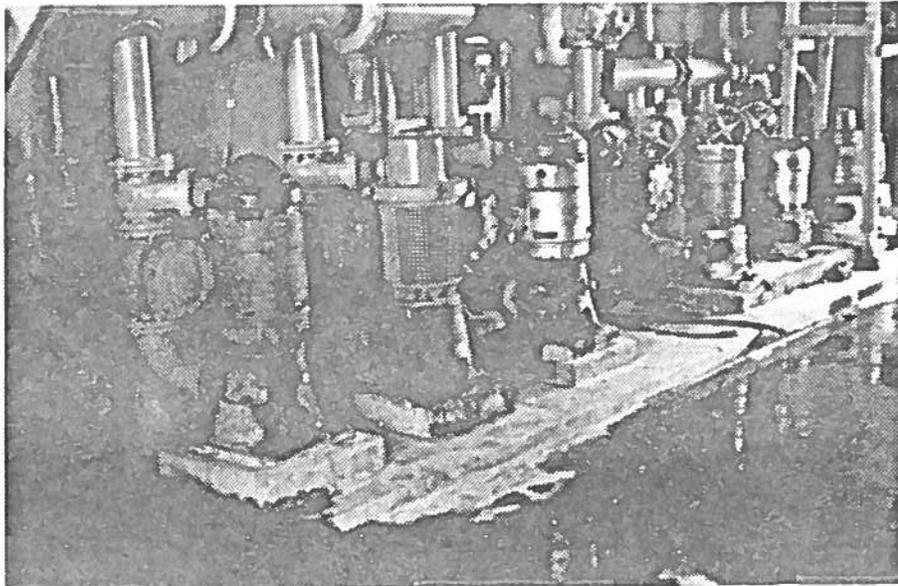
Fig. 10W-10

The total pumping capacity should be 1250 g.p.m., but was found to be 740 g.p.m., which is actually the maximum treating capacity of the water plant. The raw pumps are shown in Fig. 10W.-10.

In addition, these four raw water pumps are in very poor mechanical condition due to little or no maintenance, and the pumps being continuously subjected to sand, rocks, etc. Consequently these pumps never function for their intended design periods, and must be replaced, frequently. The pump motors do not appear to be damaged.

3 High Service Pumps on Left and 4 Raw Water Pumps on Right in Existing Water Treatment Plant.

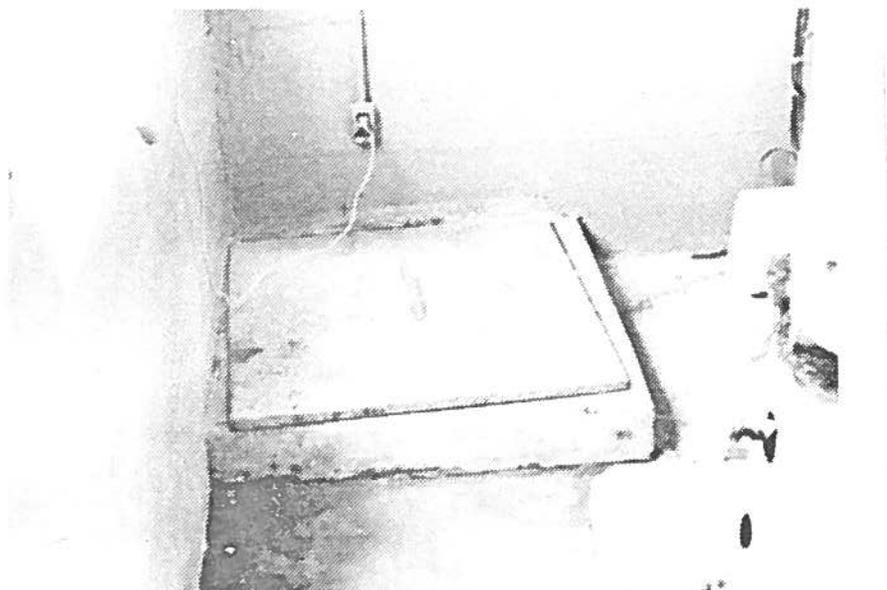
Fig. 10W-11

Clearwell Access Hatch is a Metal Lid, Not Water Tight and is Subject to Contamination in Existing Water Treatment Plant

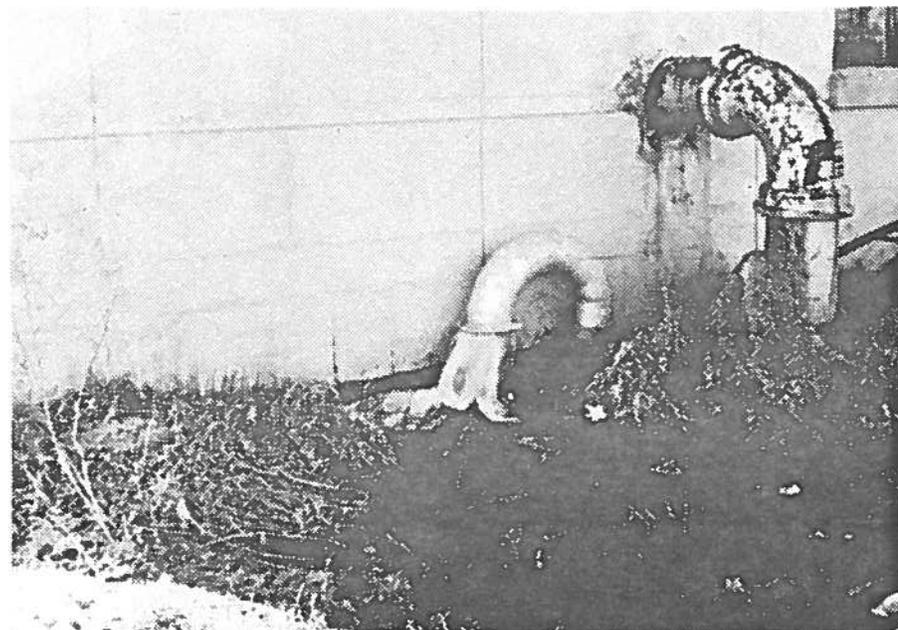
Fig. 10W-12

Clearwell Overflow/Vent Lines Overflowing at Existing Water Treatment Plant

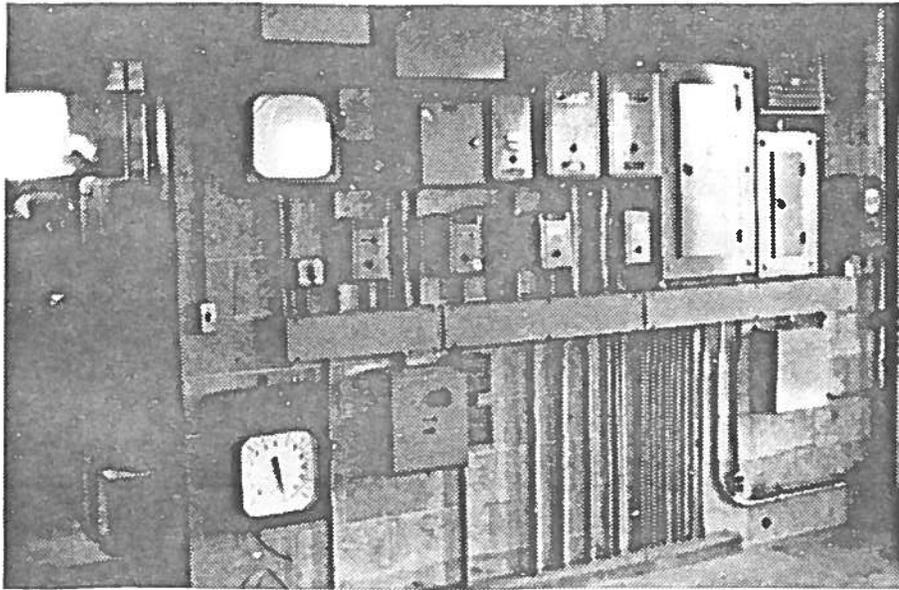
Fig. 10W-13

Existing Water Treatment
Plant Electrical Wiring
and Controls Center

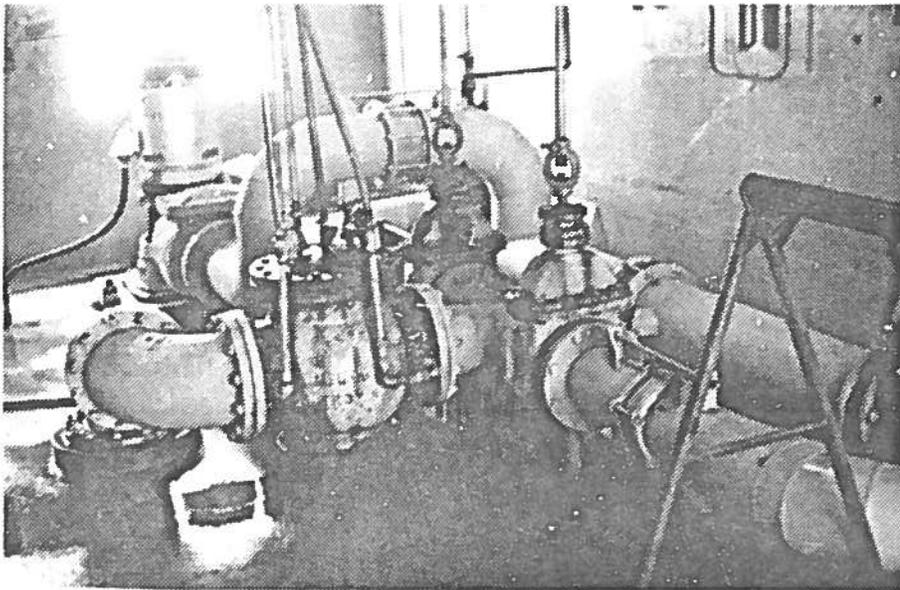
Fig. 10W-14

The filter effluent valve is designed to close automatically when the filter cycle is over, and open when demand is exerted on the system. However, this valve has been inoperable or leaked for at least one and a half years. Thus, the valve has not been closed, or maintained the filter beds in a submerged state, and the filters are allowed to dry out until the raw pumps come on again. The results of the valve not closing are listed below:

4. The pumps frequently blow fuses, and then remain inoperable until the fuses are replaced.
5. The "automatic" filter effluent valve is old, outdated, and inoperable, see Fig. 10W.-14.

Automatic Filter Effluent
Valve, "The Ross Valve"

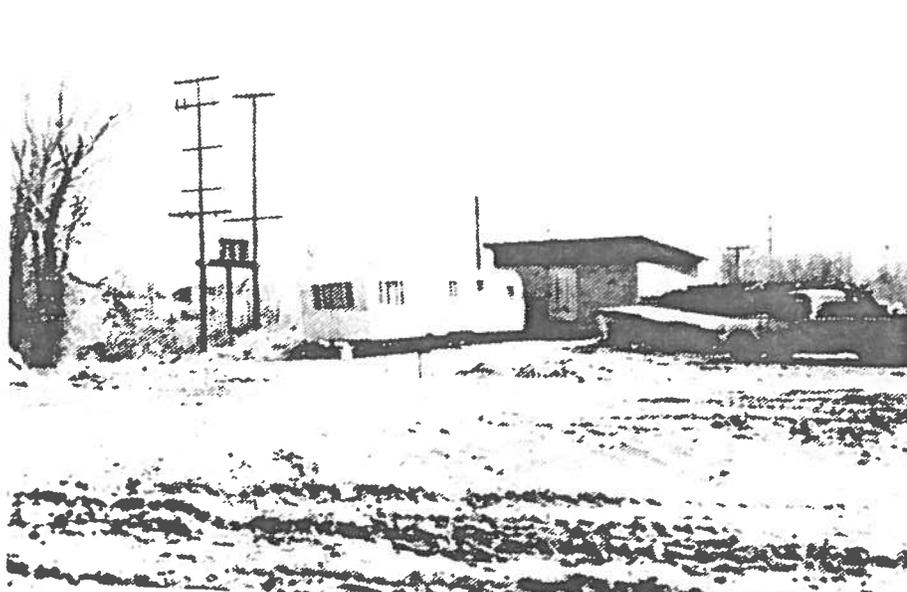
Fig. 10W-15

8. The standby power generator is not immediately operable since the battery to start it is missing. The generator is seldom maintained, or routinely switched over to run the plant as should be the case. Therefore, the generator is not ready in case of emergency, and is worthless unless maintained. Its power output capacity is limited to 240 volt power.

Standby Power Generator
in Block Building Behind
Trailer, Existing Water
Treatment Plant

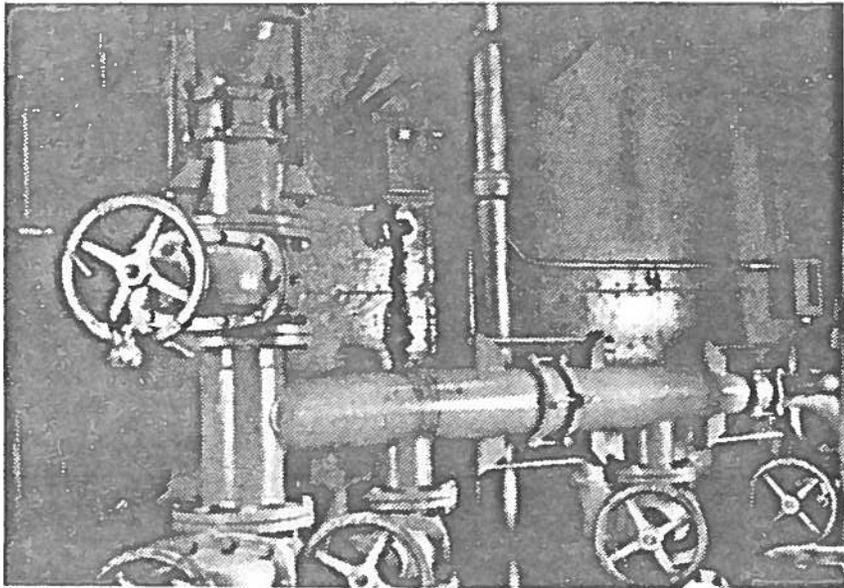
Fig. 10W-16

Chlorine-Water Solution
Introduced into Raw Water
Pump Manifold, Existing Water
Treatment Plant

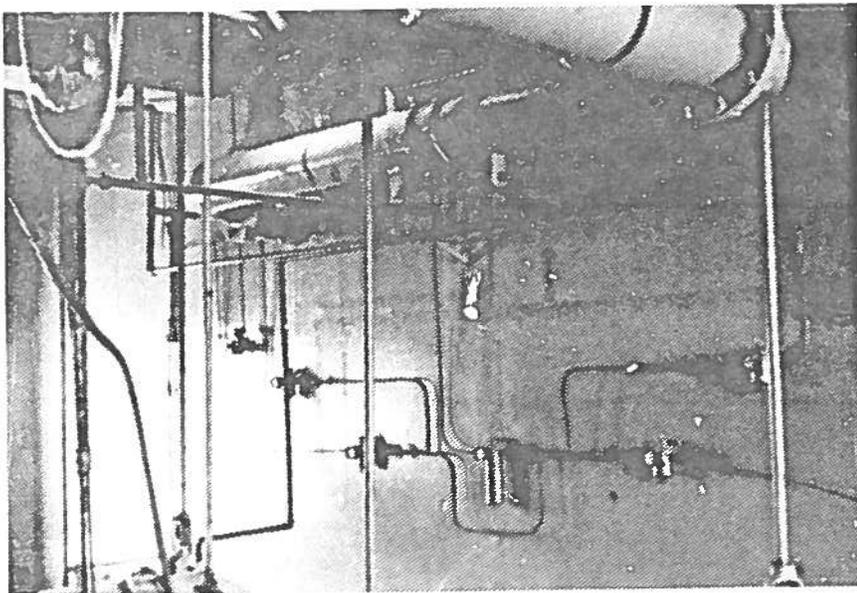
Fig. 10W-17

Non Functional Pneumatic/
Hydraulic Filter Controls
System in Existing Water
Treatment Plant

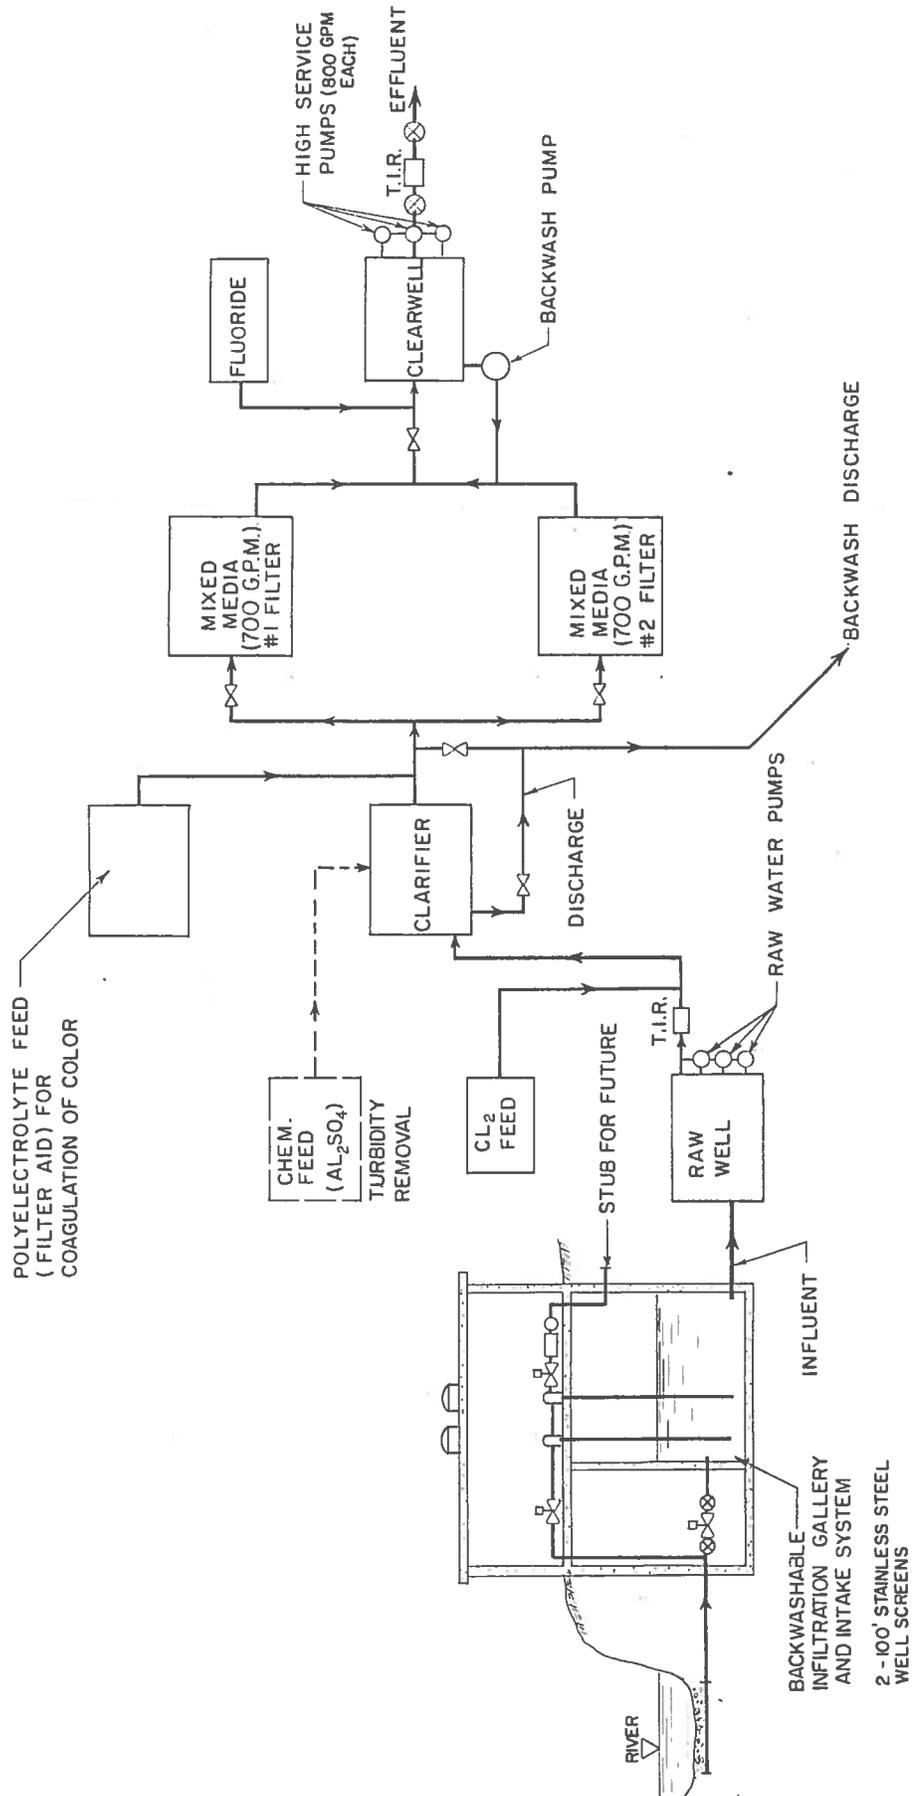
Fig. 11W.-1 schematically shows the proposed plan. This plan intends to use the existing water treatment plant and to thoroughly renovate it. The plant was inspected by W.E.A.I. and found to be structurally sound.

FIG. 11W-1
 TREATMENT OPTION NO.1
 SCHEMATIC FLOW DIAGRAM —
 MIXED MEDIA FILTRATION & PLANT RENOVATION

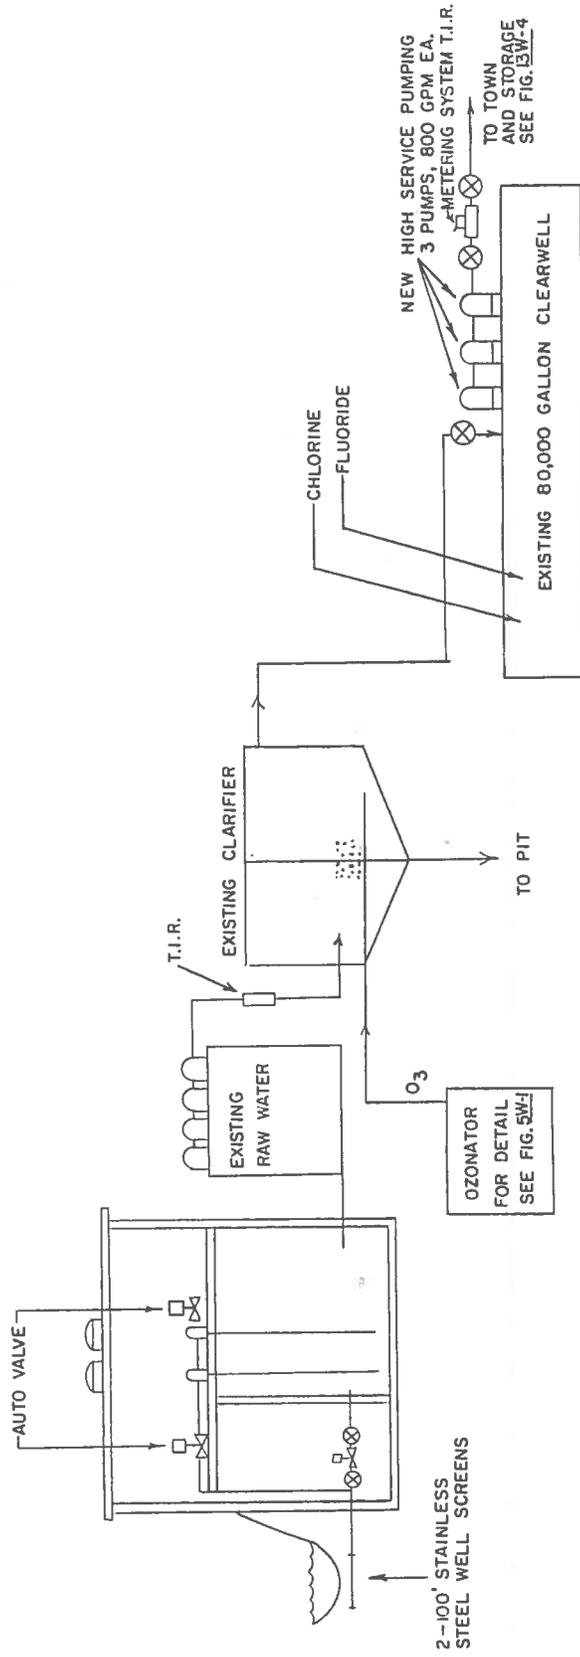
Fig. 11W.-2 shows proposed treatment Option No. 2 that includes ozonation of the raw water in the existing clarifier, followed by residual chlorination. The plan calls for abandoning the existing filter system and by passing from the raw well through the clarifier directly into the clear well. It is felt that ozone itself offers such a complete treatment system, that the filtering process through the infiltration gallery combined with color removal through ozonation, would produce a water quality that meets the new standards. The capacity of this plan is 2400 g.p.m. or 3.25 M.G.D. since the clarifier is not hydraulically limited to the rates that the filters are.

FIG. 11W-2
 TREATMENT OPTION NO. 11
 SCHEMATIC FLOW DIAGRAM
 OZONATION FOLLOWED BY RESIDUAL CHLORINATION

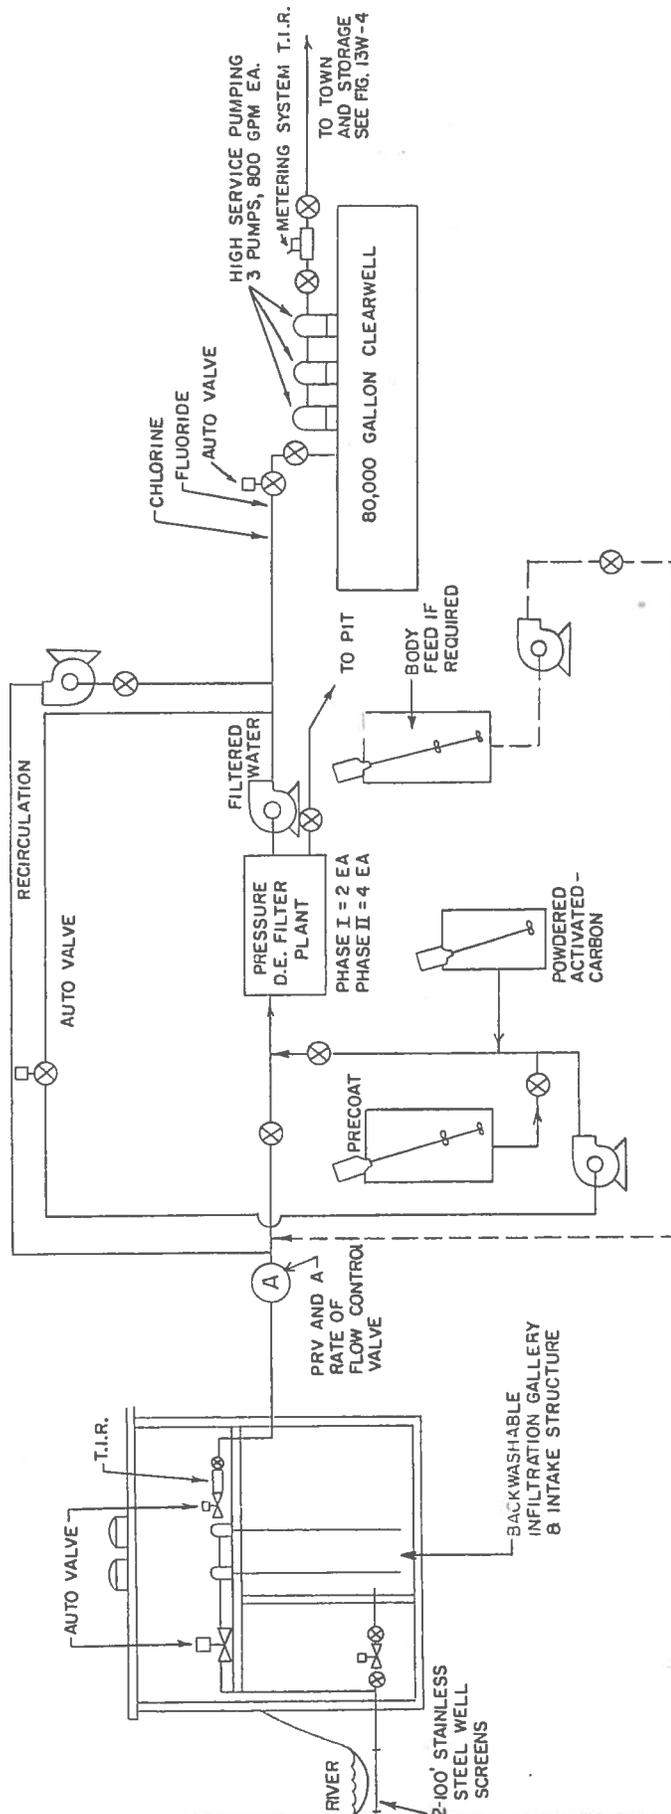
FIG. IIV-3

TREATMENT OPTION NO. III
SCHEMATIC FLOW DIAGRAM

D.E. FILTRATION, WITH ACTIVATED CARBON AS A PRECOAT AID

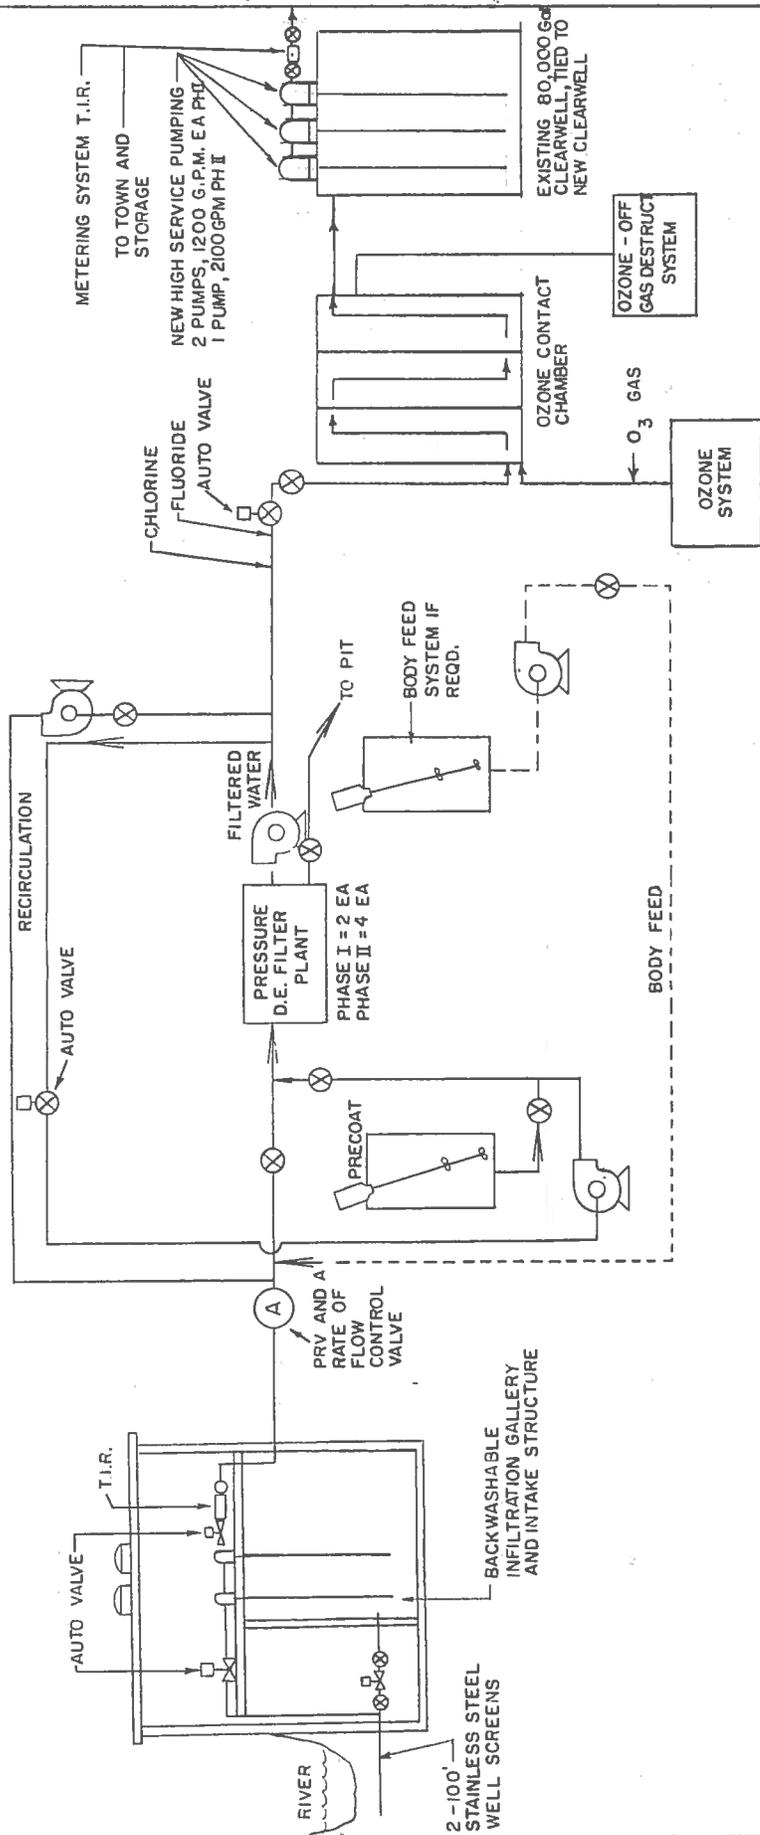
FIG. IW-4

TREATMENT OPTION NO. IV
 SCHEMATIC FLOW DIAGRAM
 D.E. FILTRATION FOLLOWED BY OZONATION AND RESIDUAL CHLORINATION

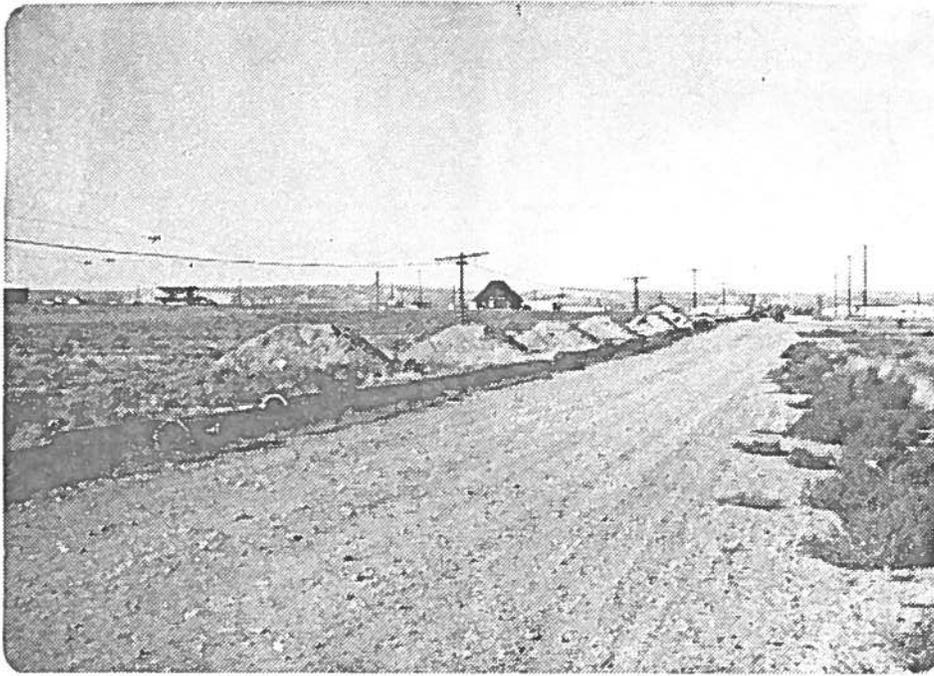
Fig. 12W-1

14 Inch Diameter
M.J.D.I.P. Pipe
Strung Along River
Street-1977

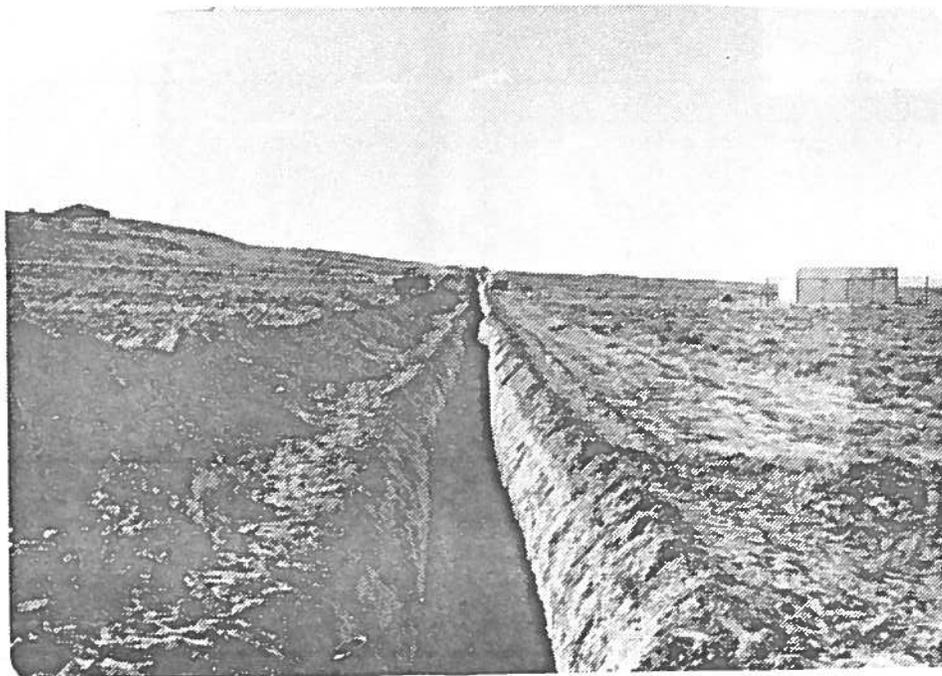
Fig. 12W-2

Pipe Trench Dug Along
Airport Avenue for
14 Inch Water Main-1977
